IEEE Transactions on Instrumentation and Measurement

Nondestructive Testing of Non-Metallic Pipelines Using Microwave Reflectometry on an In-Line Inspection Robot

Abstract—Microwave and millimeter wave reflectometry, a form of continuous-wave surface penetrating radar, is an emerging non-destructive inspection technique that is suitable for non-metallic pipelines. This article shows a K-band microwave reflectometry instrument implemented onto an in-line pipe-crawling robot, which raster-scanned cracks and external wall loss on a high-density polyethylene (HDPE) pipe of diameter 150 mm and wall thickness 9.8 mm. The pipe was scanned with three environments surrounding the pipe that approximated the use cases of over-ground HDPE pipelines, plastic-lined metal pipes, and undersea HDPE pipelines. The instrument was most sensitive when cracks were oriented parallel to its magnetic (H) plane. Any small variation in the standoff distance between the instrument's probe antenna and the pipe wall, which was not easy to avoid, was found to obscure the image. To mitigate this problem, a sensitivity analysis showed that an optimal frequency can be chosen at which standoff distance can vary by

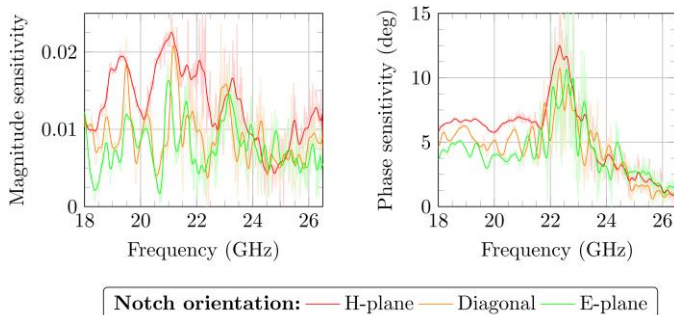
Fig. 3. Sensitivity of the magnitude and phase of S_{11} to a 1×1 mm notch on the flat HDPE sheet at different polar orientations—smoothed for clarity.

The sensitivity of the probe to the notch was calculated at each frequency from the magnitude and phase components of S_{11} separately, and plotted in Fig. 3. Sensitivity was calculated by taking the difference between the lowest and highest S_{11} measurements in the scan after removing noise and linear trends. It can be seen that the probe has double the magnitude sensitivity to notches oriented in its H-plane than in its E-plane at most frequencies. The diagonal polarization can be seen as a compromise between the H-plane and E-plane. Therefore, if the

probe is oriented diagonally to the pipe’s axis, it can equally detect cracks in both the axial and circumferential orientations on the pipe. Alternatively, higher sensitivity can be achieved by using a dual-polarized probe, such as a circular waveguide with an orthomode transducer.

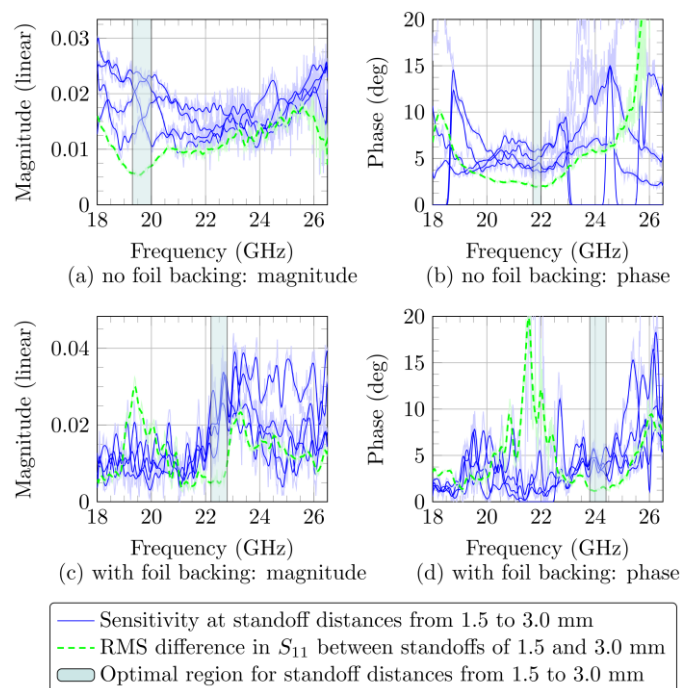
Fig. 4. Sensitivity and RMS difference (over frequency) of magnitude and phase components of S_{11} for a 1×2 mm notch on the outer surface of HDPE pipe, and optimal regions for probe standoff distances from 1.5 to 3.0 mm.

The sensitivity and RMS differences between standoff distances from 1.5 to 3.0 mm were calculated from scans of the pipe with and without aluminum foil backing and are shown in Fig. 4. The sensitivity graphs (solid blue lines) are smoothed for clarity—the original data are shown as pale-colored lines behind the smoothed data. The graphs of phase sensitivity are also pulled to zero at frequencies where their corresponding magnitude of S_{11} drops below 0.08, since the phase component is less accurate if the reflected signal received is weak.

The optimal frequency ranges are highlighted in the graphs in Fig. 4 and listed in Table I. Specific frequencies from the optimal ranges were then chosen for the 2-dimensional scans in the next section and are listed in Table II.

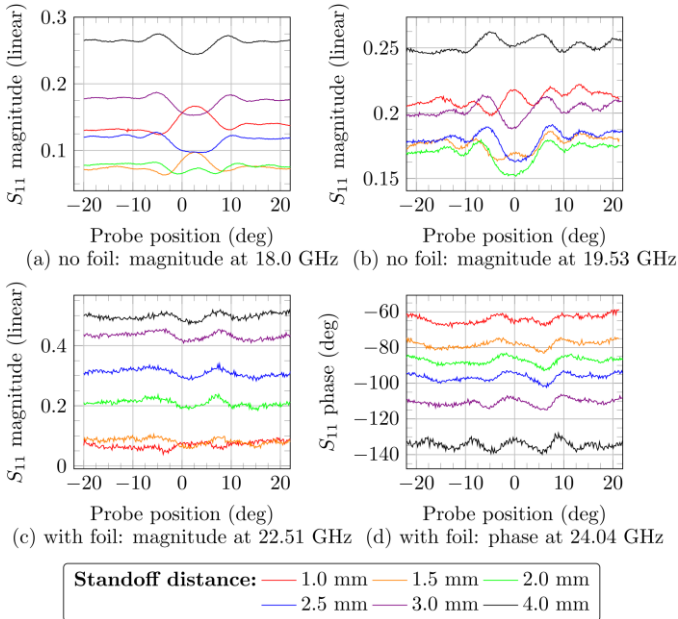
Fig. 5. Comparison of perturbations on S_{11} (scan lines) by a 1×2 mm notch on the outer surface of HDPE pipe for different standoff distances, signal frequencies and backings.

An example of a non-optimal combination of frequency and standoff distance range is 18.0 GHz and 1.0 mm to 2.5 mm respectively, within which the perturbations vary in shape with standoff distance as seen in Fig. 5 (a). An optimal combination can, however, be found between 2.5 mm and 4 mm in the same graph.

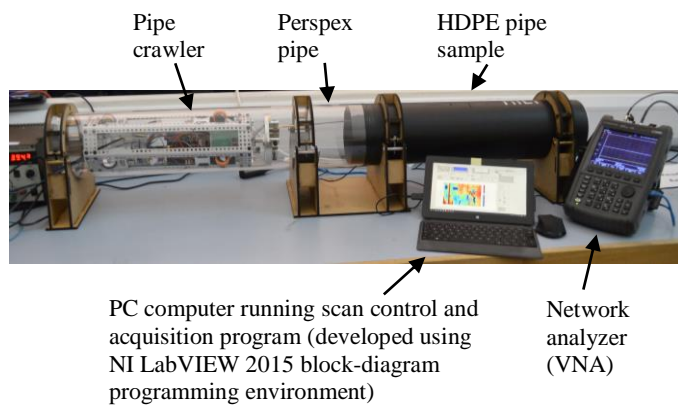
Fig. 6. Test setup for 2-dimensional scans (no foil backing).

2-dimensional cylindrical scans were performed on a second sample of the HDPE pipe using the prototype pipe crawler in the setup shown in Fig. 6.

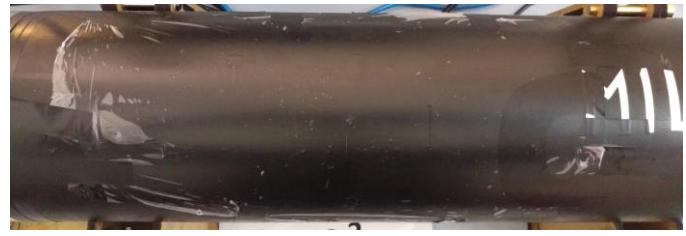
Fig. 11. Pipe sample with saltwater sealed inside defects (before aluminum foil is applied).
